Monitoring Data Record

Project Title: B-3856 (Br. #335 over Mud Creek) COE Action ID: 2007-1871-345

Stream Name: UT's to Mud Creek (Sites 1 & 3) DWQ Numbers: 070798

City, County and other Location Information: Henderson County, Bridge No. 335 over Mud Creek and approaches on SR 1238 (Pearl Lane)

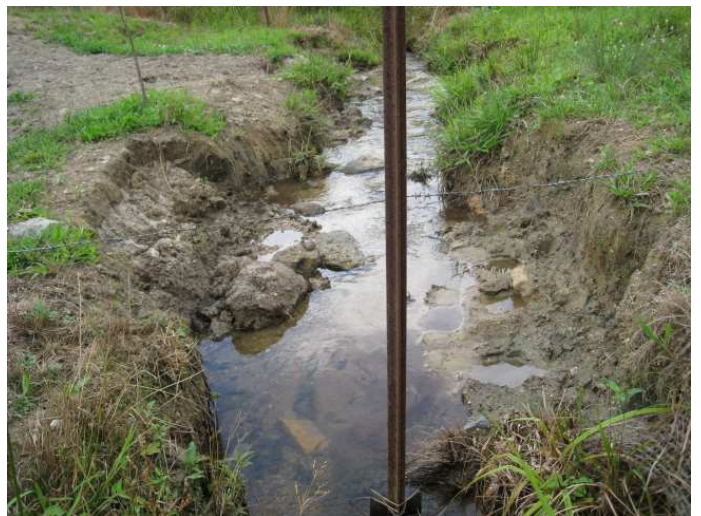
Photo Point #3 (Downstream)

Site 1 had some missing planted vegetation downstream of Photo Point #3 due to live stock grazing from the adjacent landowner.

Date Inspected 7/28/10	Station Number 13+00-L- Downstream of Photo Point #3 @ Site 1	Station Number	Station Number	Station Number	Station Number
Structure Type	.				
Is water piping through or around structure?					
Head cut or down cut present?					
Bank or scour erosion present?	Bank erosion from live stock				
Other problems noted?

NCDOT plans to contact the landowner to remove the live stock from the stream. This area will be repaired and replanted.

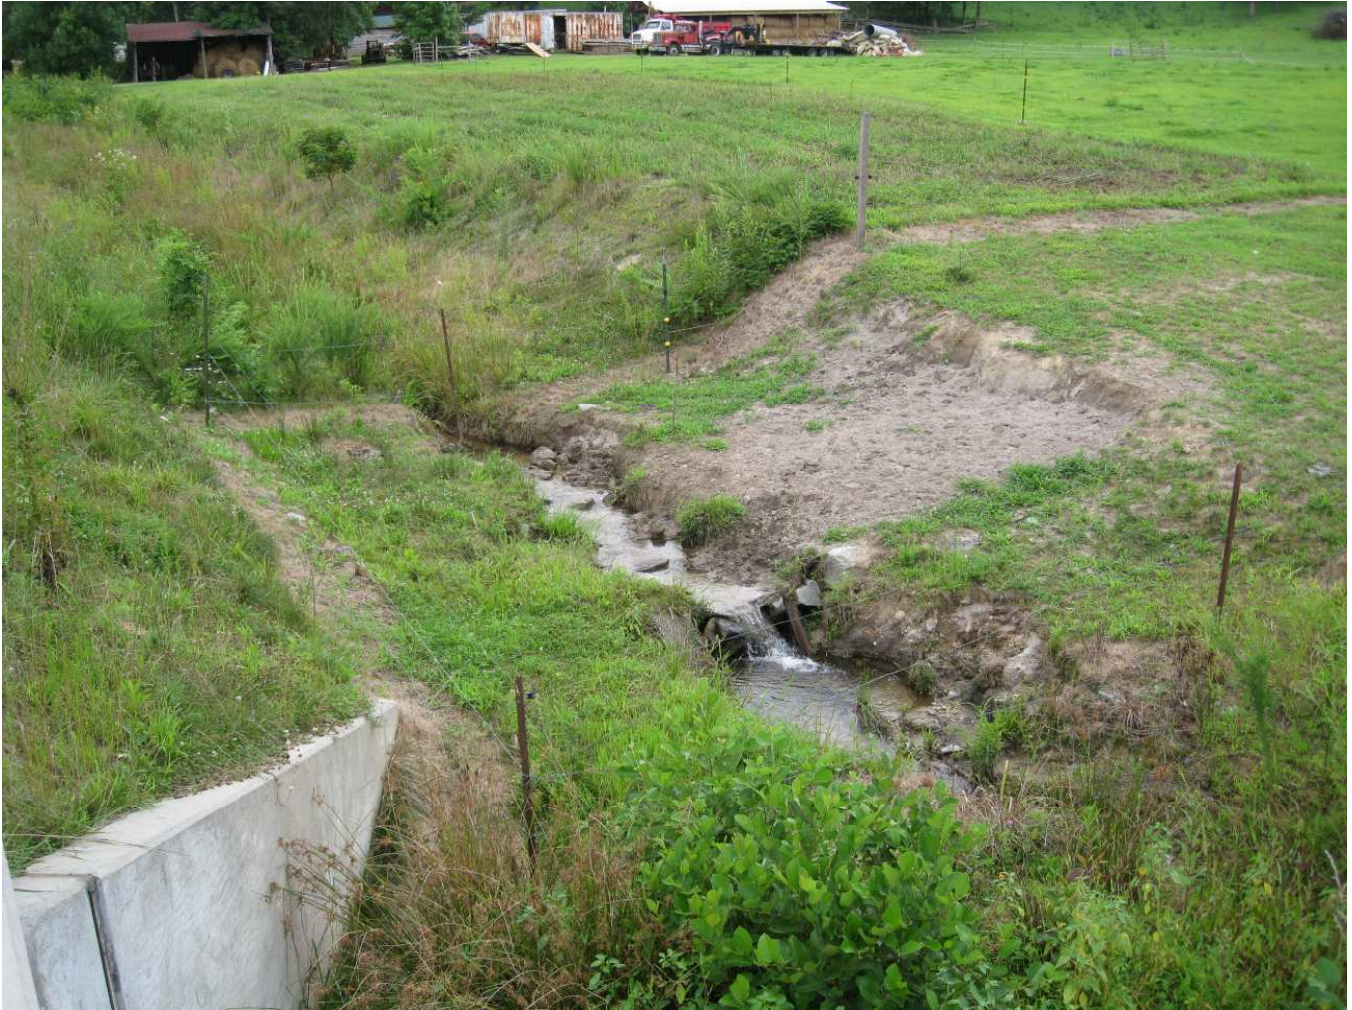
Site 1 (Adjacent Landowner fenced in stream for livestock watering)
